GRIEVES WOOLEN MILL  
ILO# 001091990  
MARSHALL COUNTY, IL  
IEPA 1230100009  
SF / HRS

# **CERCLA**

## **Integrated Site**

**Illinois Environmental  
Protection Agency**

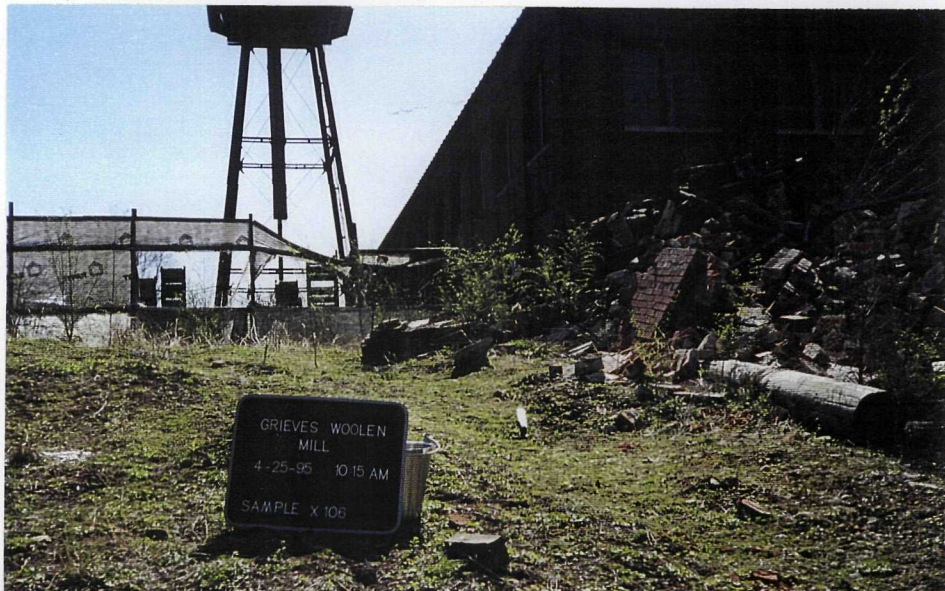
Sample X106 was collected 39 feet south of the north property line in an area of reddish discolored soil. The soil was a reddish purple color with a fine yellow powder like material. The sample was collected from zero to six inches in depth with a stainless steel trowel.

COMMENTS: Photo #1 taken toward the east. Sample X106	
on discolored soil	
north of boiler	
room.

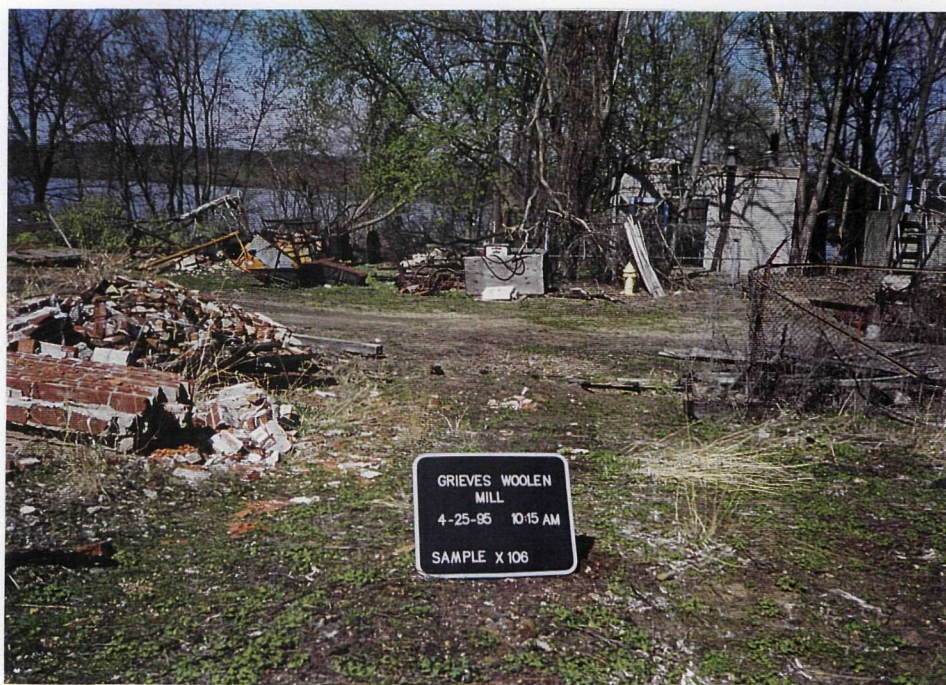
DATE: 4-25-95
TIME: 10:15 am
PHOTOGRAPH TAKEN BY: T. Prescott
COMMENTS: Photo #2 taken to west. Sample X106 taken
on discolored soil

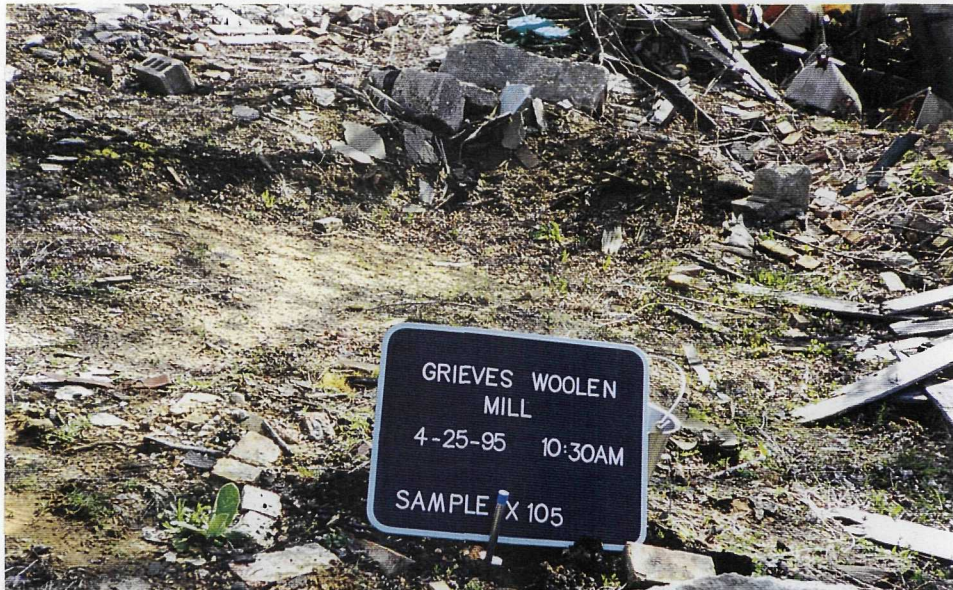
Sample X105 was collected 13 feet north of the Picking room wall. The area around this sample point was discolored with a yellowish tint. The soil was reddish brown sand at the surface and a darker red to black around six inches. The sample was collected from zero to six inches in depth with a stainless steel trowel.

Soil sample X105 was collected 72 feet east of the center of Water Street and 13 feet north of the north wall of the Picking room in the gap between the Dye house and the Picking room. This was a discolored soil area. The pesticide Dieldrin and Lead were found above background. Neither contaminant met or exceeded the RALs or SCDMs benchmarks.

COMMENTS: Photo #3 taken to east.	
Sample X105 taken on discolored soil north of Picking room.

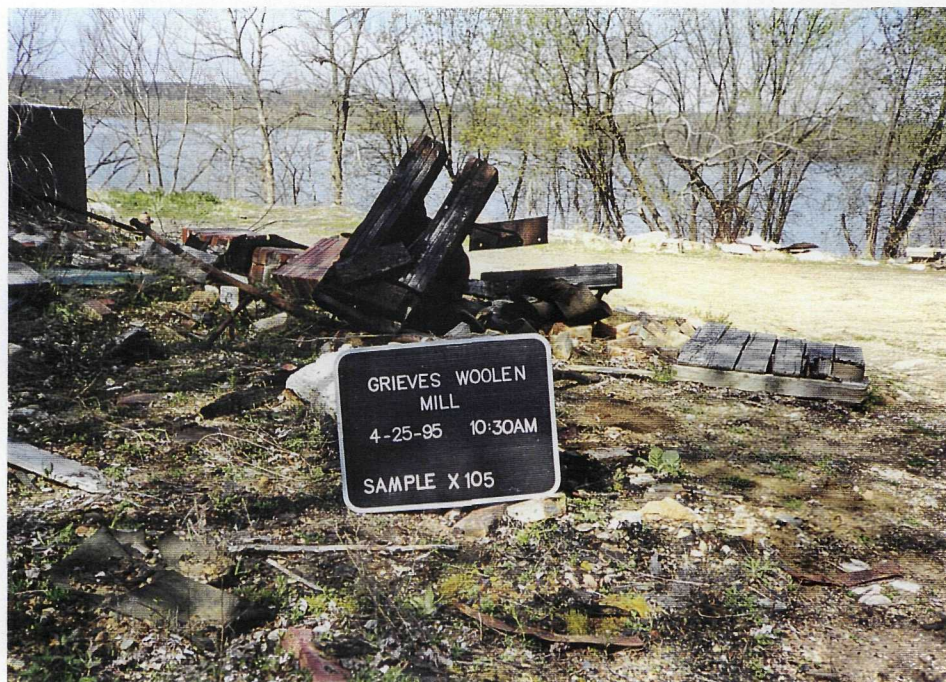
DATE: 4-25-95
TIME: 10:30 am
PHOTOGRAPH TAKEN BY: T. Prescott
COMMENTS: Photo #4 taken to west.
Sample X105 taken on discolored soil
Note: Illinois River and Water St. in background.

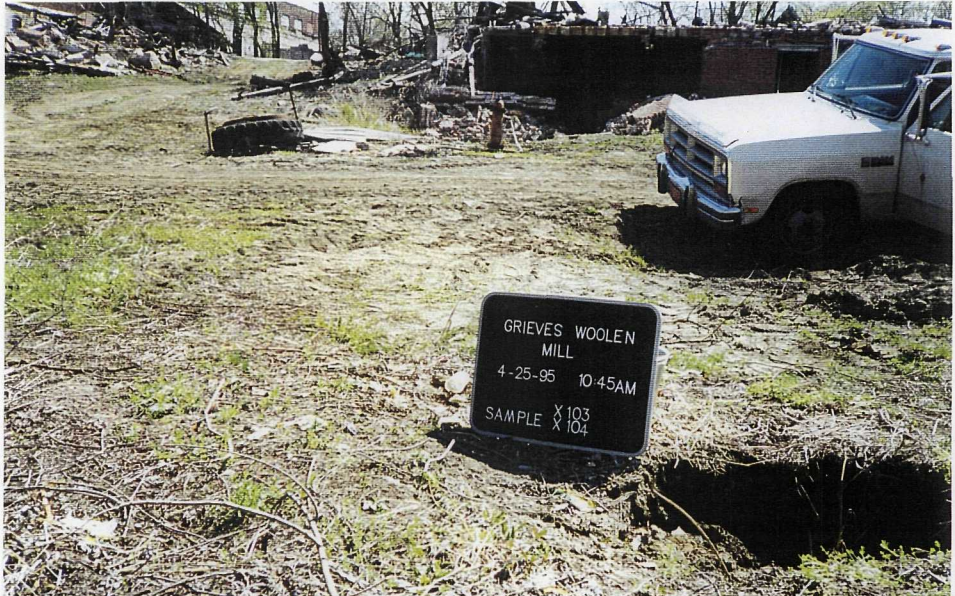
Sample X103 and X104 are duplicate samples collected 60 feet west of the Picking room. There was a three foot deep excavation where a drain line was located. The sample was collected from zero to six inches in depth at the bottom of the hole with a stainless steel trowel. Soil that was obtained for

Soil Samples X103 and X104 were duplicate samples collected at the bottom of a three foot diameter, approximately two foot deep hole sixty feet west of the northwest corner of the Picking Room along the berm, where an underground pipe had recently been removed. Eight semivolatiles, nine pesticides and eight inorganic contaminants (including Chromium) were found above background. Seven of the semivolatiles and four of the pesticides met or exceeded the RALs or the SCDMs benchmarks.

COMMENTS: Photo #5 taken to east.	
Duplicate Samples	
X103 & X104 taken	
at hole where	
drain pipe was removed. Picking room is in back.

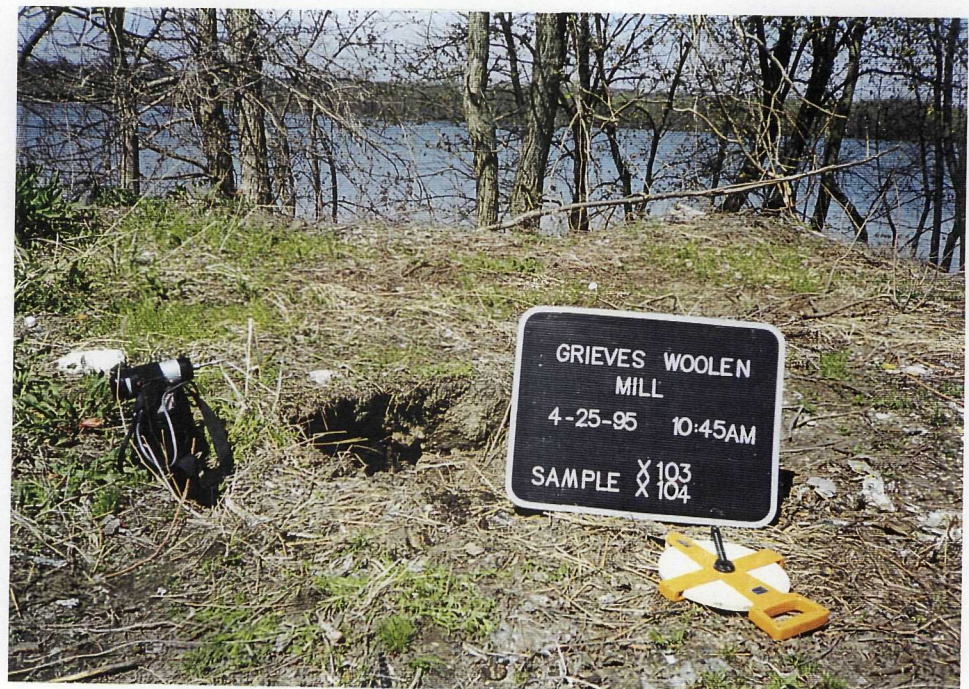
DATE: 4-25-95
TIME: 10:45 am
PHOTOGRAPH TAKEN BY: T. Prescott
COMMENTS: Photo #6 taken to west.
Duplicate samples
X103 & X104 taken
at top of bluff
to Illinois River floodplain.

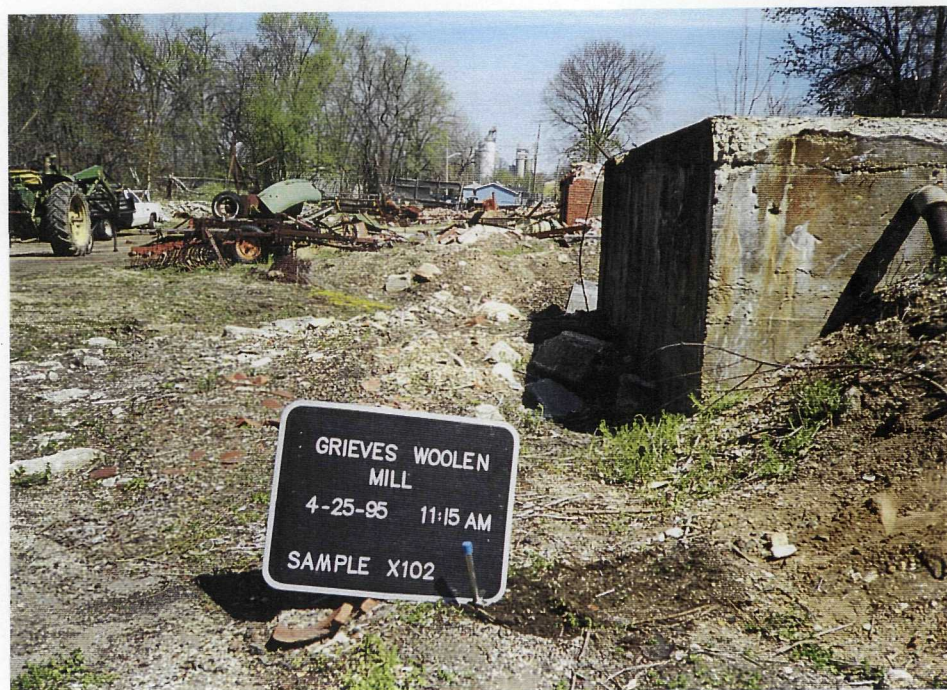
Sample X102 was collected three feet west of the fuel tank. The sample was taken in an area where a drain tile and the fuel tank may have had releases. The sample appearance was brownish red with pebbles and was collected from zero to six inches in depth with a stainless steel trowel.

DATE: 4-25-95	SITE ILO#: 001091990 COUNTY: Marshall
TIME: 11:15 am	SITE NAME: Grieves Woolen Mill
PHOTOGRAPH TAKEN BY: T. Prescott	
COMMENTS: Photo #7 taken to north.	
Sample X102 taken at end of broken drain line & at lower edge of fuel tanks.

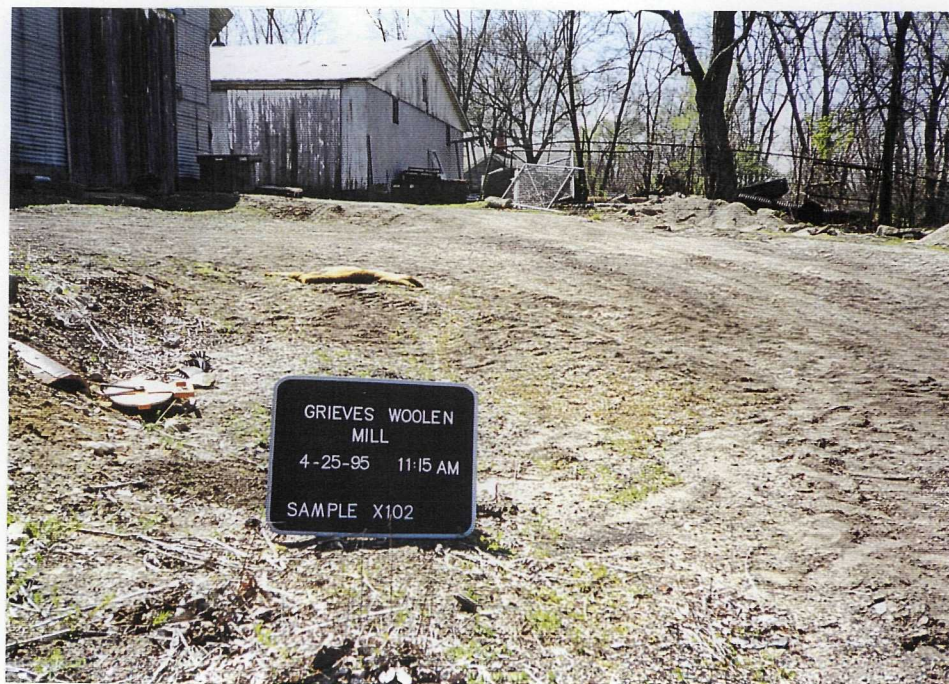
DATE: 4-25-95
TIME: 11:15 am
PHOTOGRAPH TAKEN BY: T. Prescott
COMMENTS: Photo #8 taken to south.
Sample X102 taken at drain line.
Note: drain tile at left in photo.

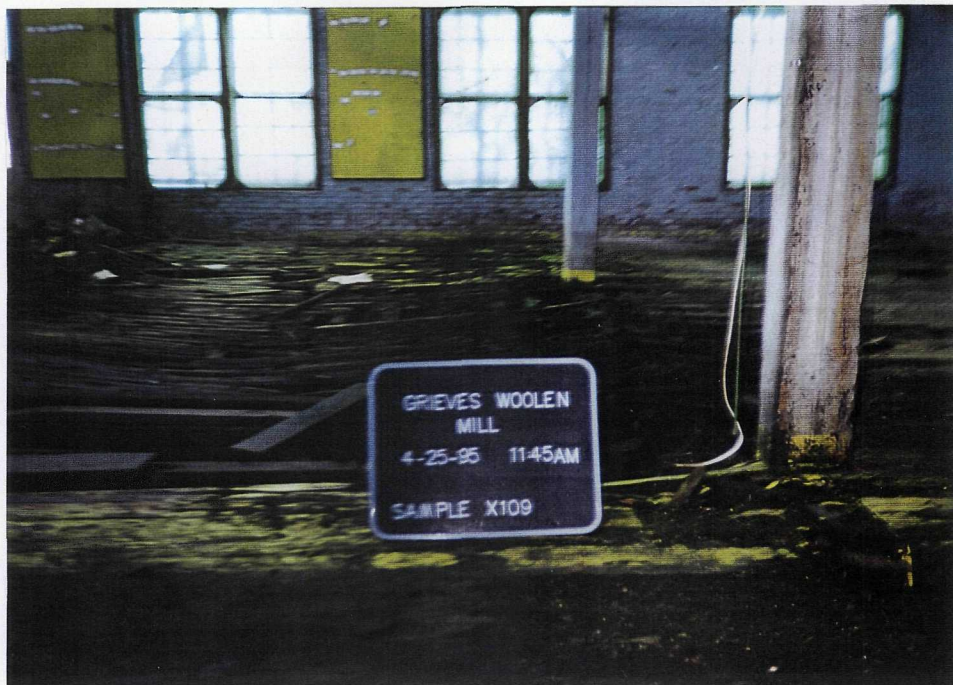
Sample X109 was collected from under the rotted floor of the finishing room in the main building. The soil was a dark loam with sand around eight inches. The sample was collected with a stainless steel split spoon auger from zero to eight inches in depth.

Soil sample X109 was collected 31 feet east of the west wall and 36 feet north of the south wall of the dye house / finishing room. The floor in the room is rotted through exposing the soil beneath it. Two pesticides and Mercury were found above background levels and none of them met or exceeded

COMMENTS: Photo #9 taken to east.	
Sample X109 taken under rotted floor of old Finishing room.

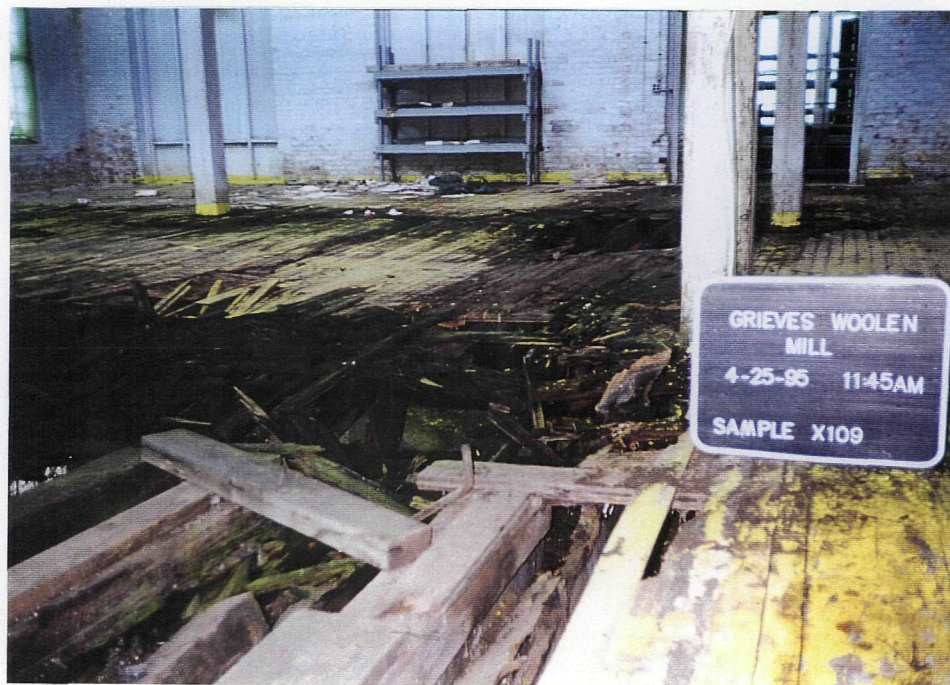
DATE: 4-25-95
TIME: 11:45 am
PHOTOGRAPH TAKEN BY: T. Prescott
COMMENTS: Photo 10 taken to south.
Sample X109 taken in Finishing room. Floor was broken.

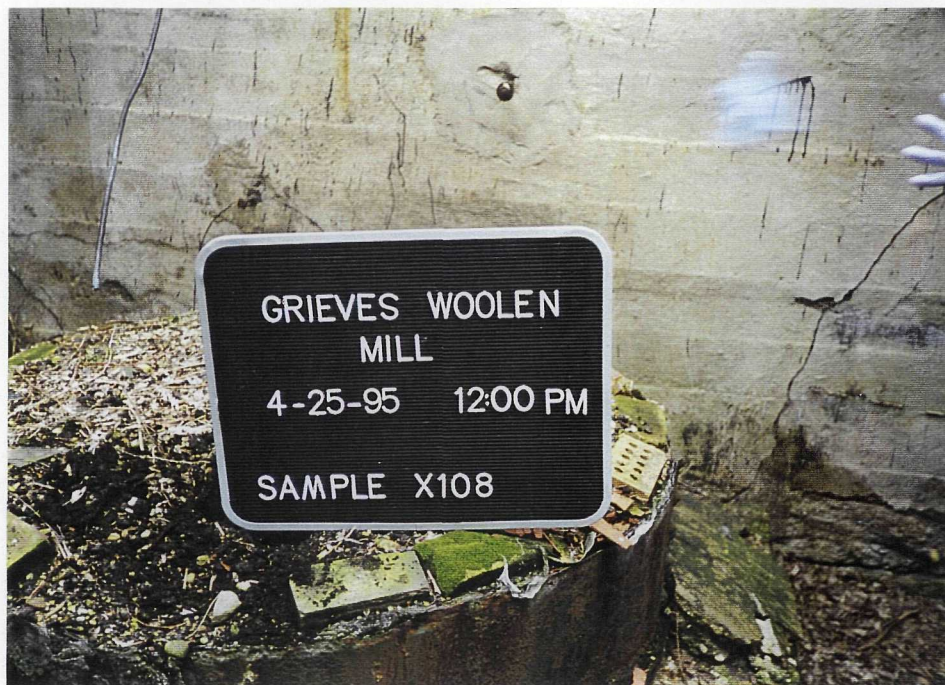
Sample X108 was collected from the top of the dye incinerator. The material was a black maroonish gritty sand and was wet and cohesive. The sample was collected from zero to six inches in depth with a stainless steel trowel.

Soil sample X108 was collected on top of the remains of the Dye Incinerator. Seven semivolatiles, five pesticides and ten inorganic contaminants (including Chromium) were found above background levels. Six of the semivolatiles and four pesticides met or exceeded the RALs or SCDMs benchmarks.

DATE: 4-25-95	SITE ILO#: 001091990      COUNTY: Marshall
TIME: 12:00 pm	SITE NAME: Grieves Woolen Mill
PHOTOGRAPH TAKEN BY: T. Prescott	
COMMENTS: Photo 11 taken to east.	
Sample X108 taken on top of Dye Incinerator tank.

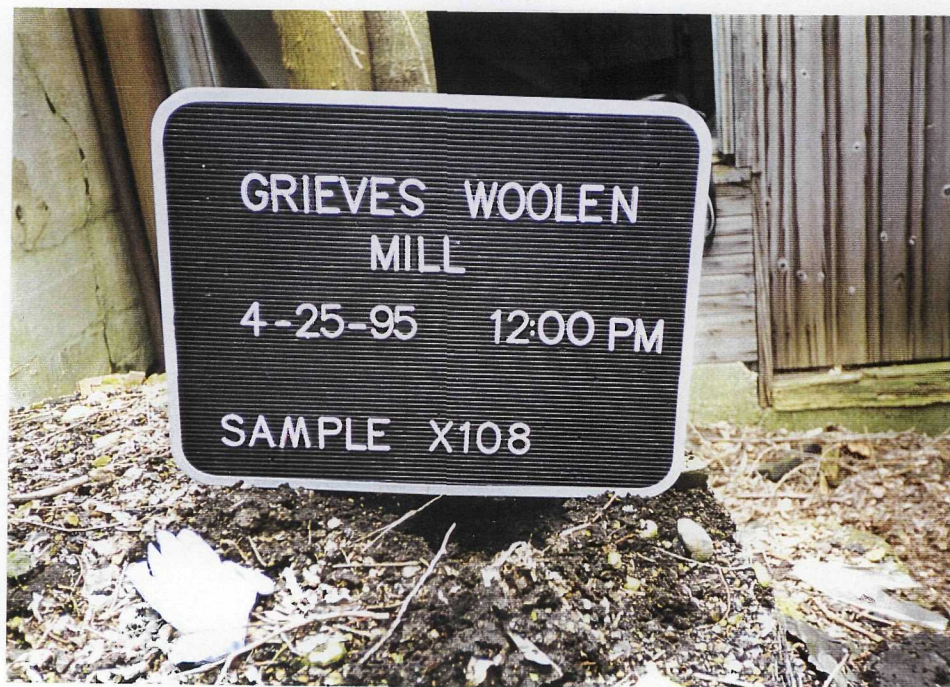
DATE: 4-25-95
TIME: 12:00 pm
PHOTOGRAPH TAKEN BY: T. Prescott
COMMENTS: Photo 12 taken to north.
Sample X108 taken on top of Dye Incinerator tank.

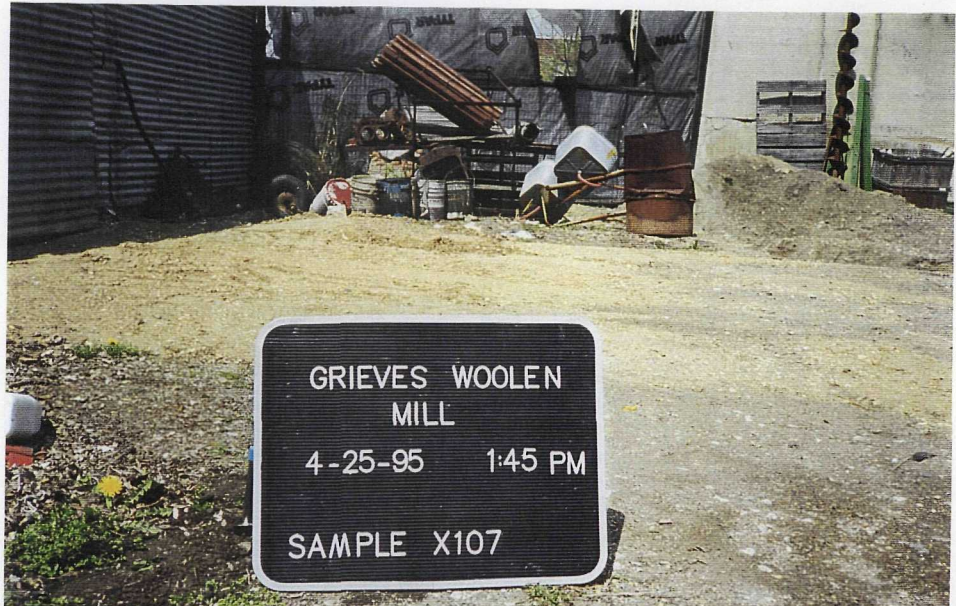
Sample X107 was collected from the sulfuric acid tank location. The soil was a black clay loam. The sample was collected from zero to six inches in depth with a stainless steel trowel.

Soil sample X107 was collected 10.5 feet east of the east wall and eight feet north of the south wall of the western metal building. This sample corresponds with the location of a sulfuric acid tank that allegedly spilled its contents over time into the soil. This is also a discolored soil area. Seven semivolatiles, three pesticides and eight inorganic contaminants (including Chromium) were found above background levels. Six semivolatiles and two pesticides met or exceeded the RALs or SCDMs benchmarks.

COMMENTS: Photo 13 taken to north.	
Sample X107 taken near 1000gal tank of H2SO4 may have leaked.

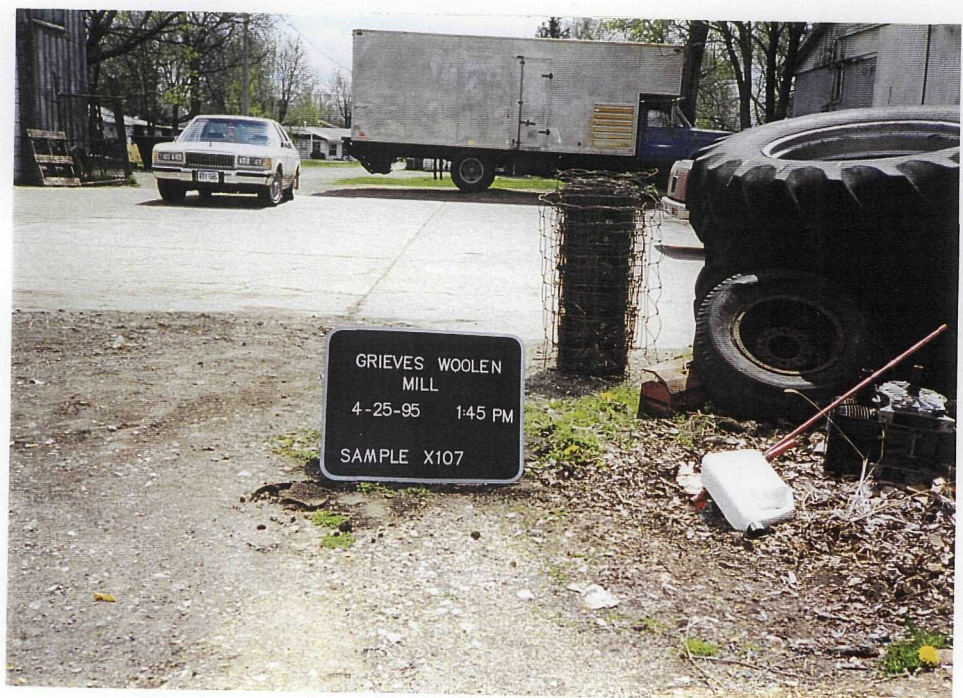
DATE: 4-25-95
TIME: 1:45 pm
PHOTOGRAPH TAKEN BY: T. Prescott
COMMENTS: Photo 14 taken to south.
Sample X107 taken near old H2SO4 tank may have leaked.

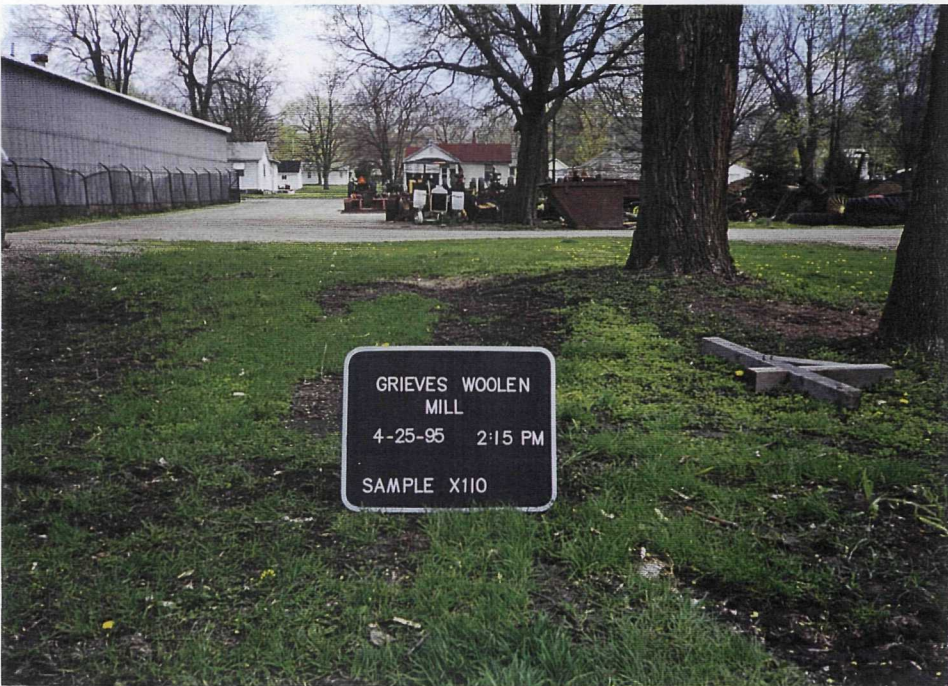
Sample X110 was collected from the residential yard immediately south of the site. The soil was a dark brown sandy/pebbly loam. The sample was collected from zero to four inches in depth with a stainless steel trowel.

Soil sample X110 was collected on the northeast lawn of a private residence immediately south of the mill property. Flouranthene and Pyrene along with 4,4-DDE, Endrin, 4,4-DDT and eleven inorganics were found above background. Flouranthene and Pyrene met or exceeded the RALs or SCDMs benchmarks.

COMMENTS: Photo 15 taken to east.	
Sample X110 taken at residence just south of site.

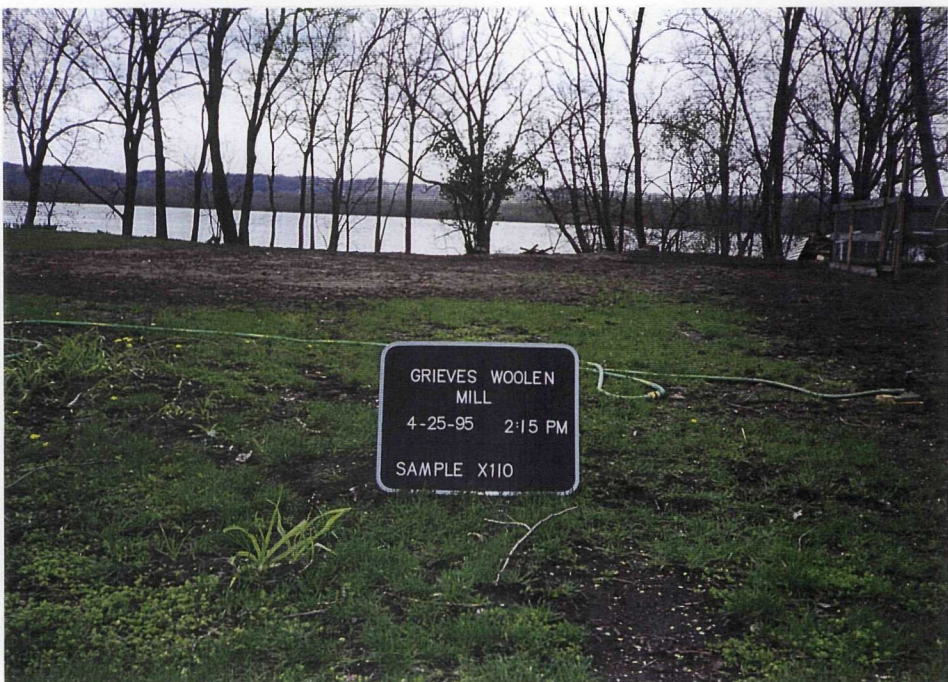
DATE: 4-25-95
TIME: 2:15 pm
PHOTOGRAPH TAKEN BY: T. Prescott
COMMENTS: Photo 16 taken to west.
Sample X110 taken at residence just south of site.

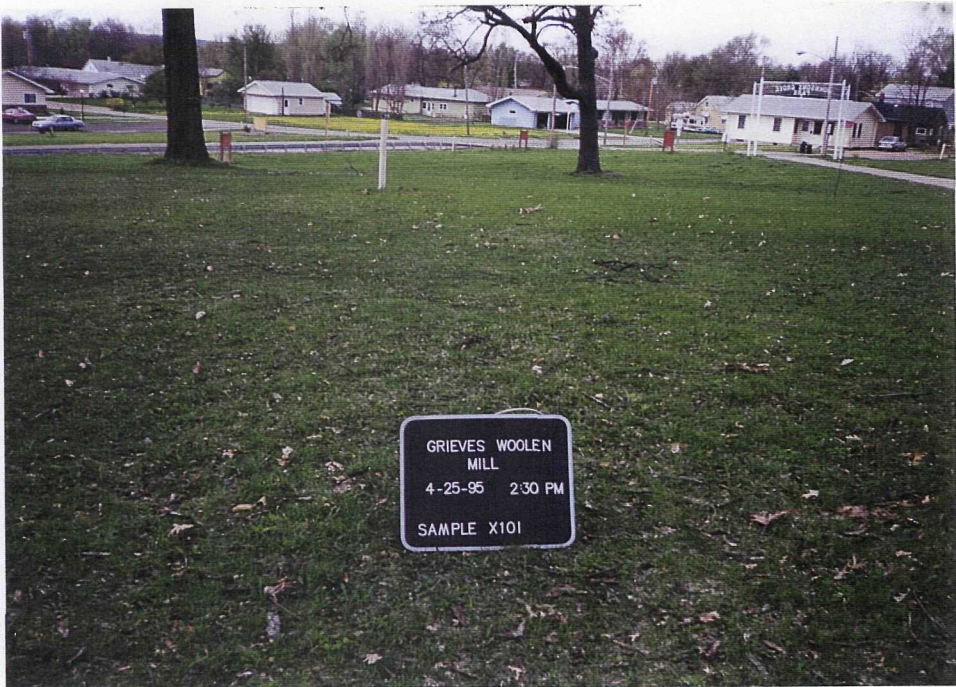
COMMENTS: Photo 17 taken to north.	
Sample X101 taken at northwest edge of Johnson Grove Park.

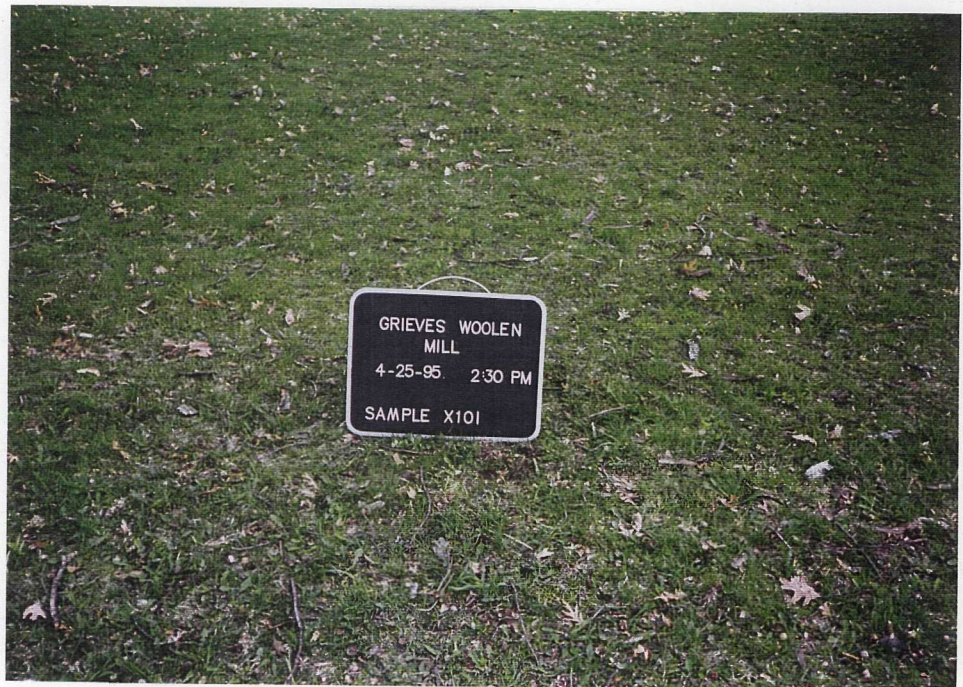
DATE: 4-25-95
TIME: 2:30 pm
PHOTOGRAPH TAKEN BY: T. Prescott
COMMENTS: Photo 18 taken to south.
Background Sample X101 taken at Johnson Grove Park

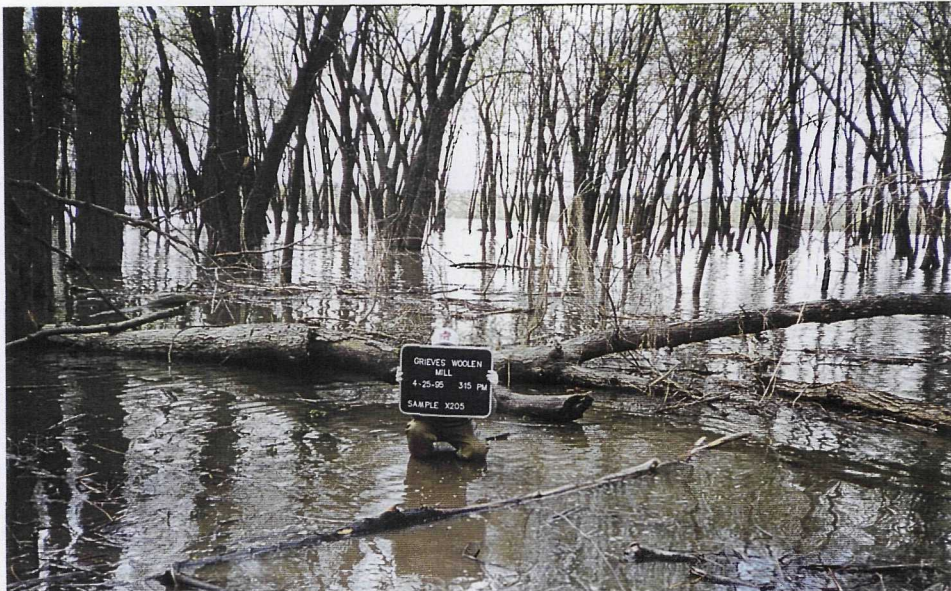
Sample X205 was collected due west of the sewage treatment facility approximately two tenths of a mile down stream. The sample was collected at the north edge of the Marshall County State Conservation Area in the flooded wetland area. The sample was a brown silty clay and was collected from zero to sixteen inches and in two feet of water with a stainless steel split spoon auger.

Sediment sample X205 was collected in zero to eighteen inches of sediment, approximately two feet under the water surface. The sample location was at the start of the Marshall County State Conservation Area, three tenths of a mile down stream from the site. No contaminants were found above background or met the RALs or SCDMs benchmarks.

COMMENTS: Photo 19 taken to west.	
Sample X205 taken in flooded area west of sewage treatment facility south of site.

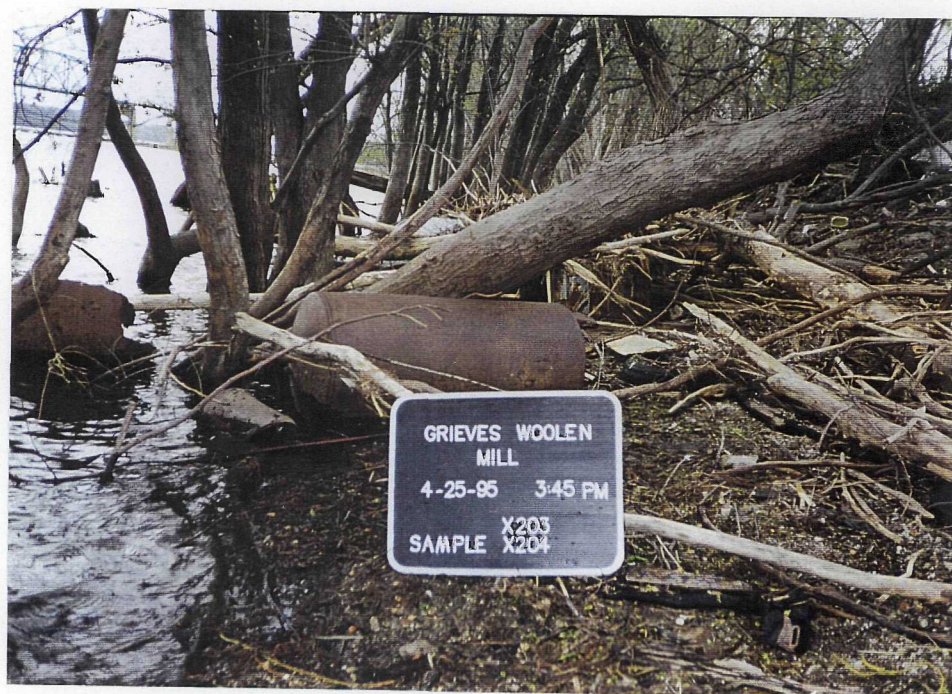
sediment, approximately two feet under the water surface. The sample location was due west of the northwestern metal building at the bottom of the bluff. Seven semivolatiles, six pesticides and nine inorganic contaminants (including Chromium) were found above background levels. Six of the semivolatiles, Aldrin, Dieldrin and Chromium met or exceeded the RALs or SCDMs benchmarks. Dieldrin was found to be more than twice the background level.

DATE: 4-25-95
TIME: 3:45 pm
PHOTOGRAPH TAKEN BY: T. Prescott
COMMENTS: Photo 20 taken to north.
Duplicate samples X203 & X204 taken at bottom of bluff in flooded area west of Picking room.

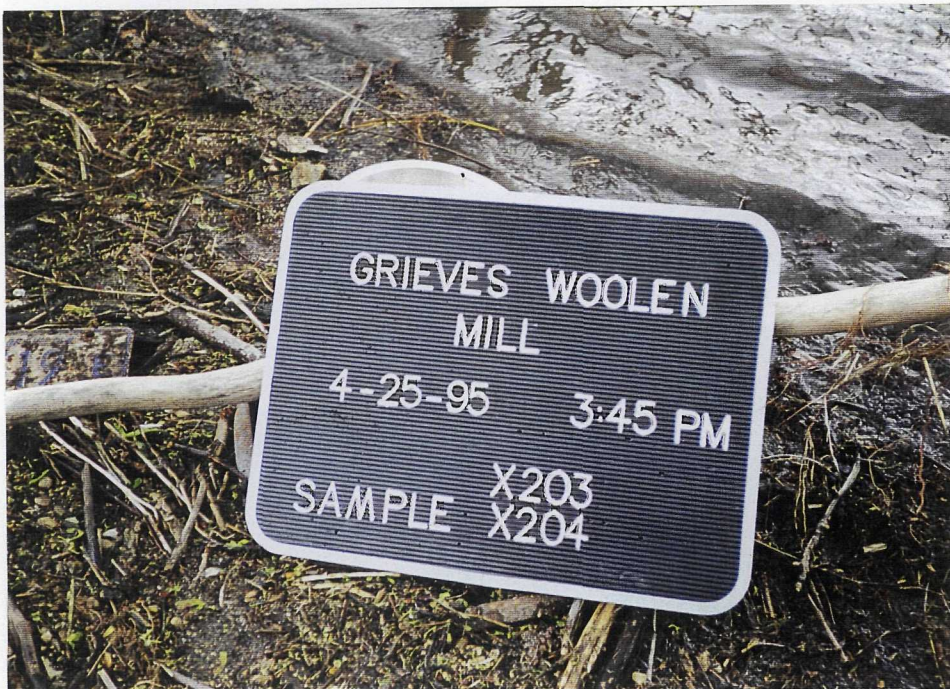
COMMENTS: Photo 21 taken to west.	
Duplicate samples	
X203 & X204 taken	
in Illinois River floodplain.

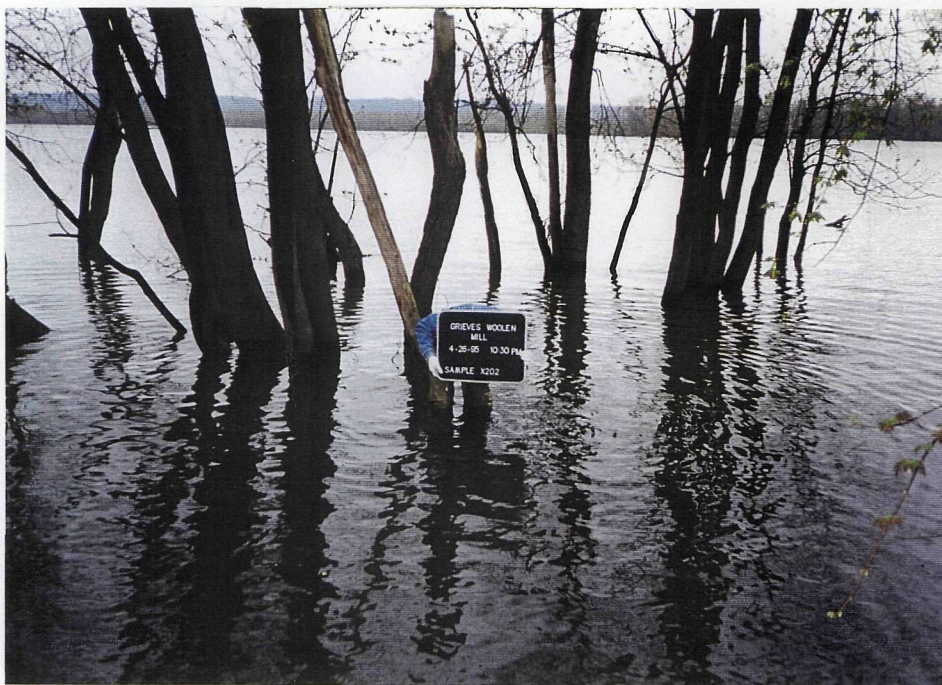
Sample X202 was collected along the bluff line 60 feet west of the center of Water Street and 46.5 feet north of the Picking room wall. The sediment was a dark grey sandy/gritty silt and was collected from six to eight inches in two feet of water with a stainless steel split spoon auger.

Sediment sample X202 was collected on the flooded over floodplain in six to eight inches of sediment, approximately two feet under the water surface. The sample location was 60 feet west of the center of water Street and 46.5 feet north of the north wall of the picking room. Four semivolatiles, two pesticides and six inorganic contaminants (including Chromium) were found above background. All the semivolatiles, pesticides and Chromium met or exceeded the RALs or SCDMs benchmarks. Dieldrin was found to be more than fifty times greater than the background level.

DATE: 4-26-95
TIME: 10:30 am
PHOTOGRAPH TAKEN BY: T. Prescott
COMMENTS: Photo 22 taken to west.
Sample X202 taken
in flooded banks
of Illinois River.
Note: time is <u>am</u>
Note: tree line
indicates normal
river bank.

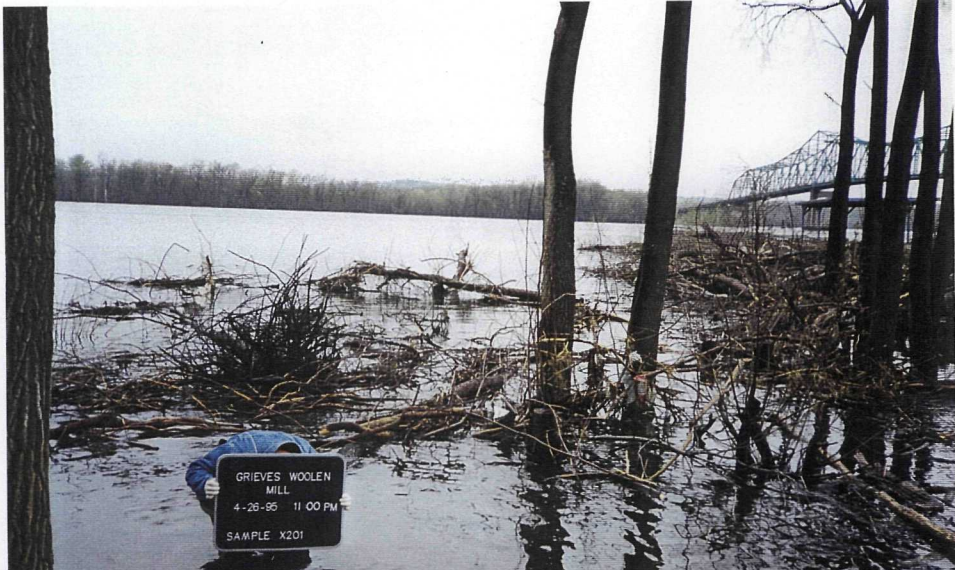
COMMENTS: Photo 23 taken to west.	
Background Sample taken between site and marina in flooded plain.	
Note: time should be 11:00 <u>am</u> .

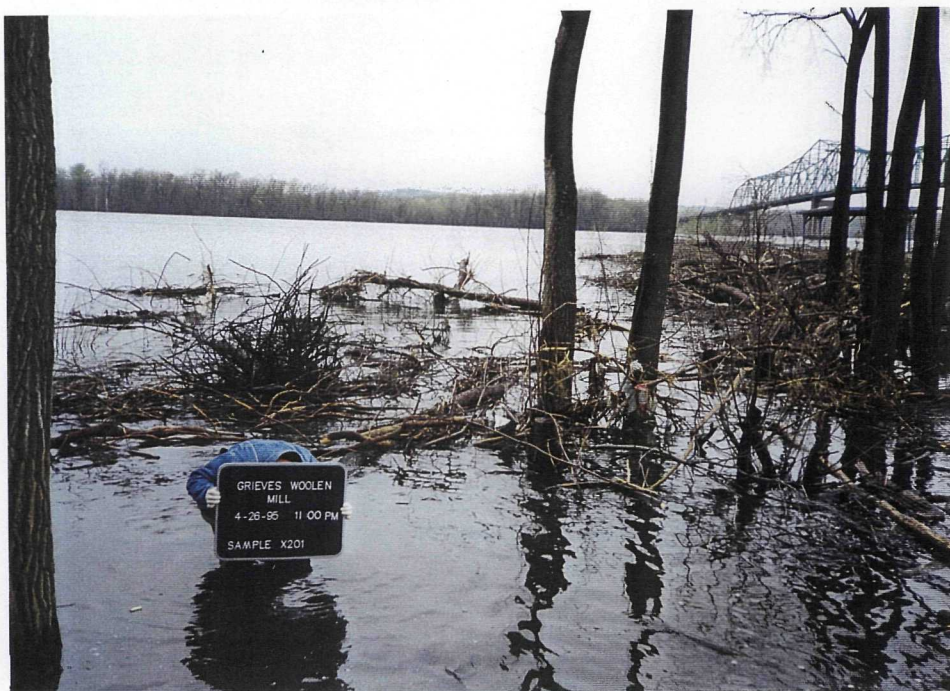
Sample X201 was a background sediment sample collected at the turn of the river immediately south of the marina. All sediment samples were compared to this sample. The sediment was a dark grey sandy/gritty silt with gravel. The sample was collected from zero to sixteen inches and in two feet of water with a stainless steel split spoon auger.

Background sediment sample X201 was collected 39 feet east and 60 feet south of the southeast edge of the gravel parking lot of the marina, just north of the site. Dieldrin was found to exceed the RALs or SCDMs benchmarks.

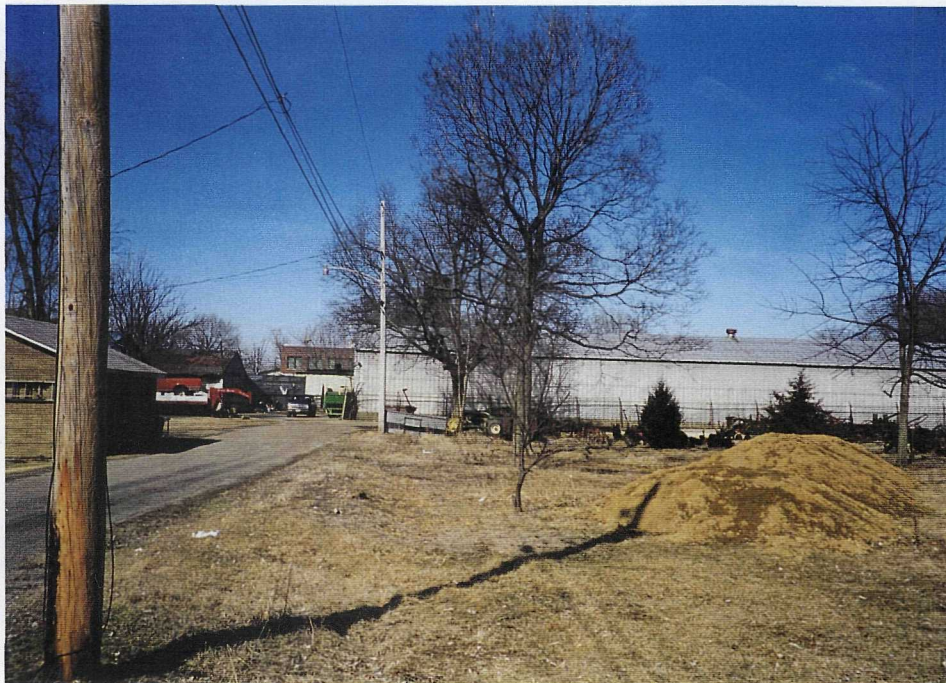
PICTURE TAKEN TOWARD  
the Northwest

.Photo of Bldg debris in  
.field, metal bldgs behind  
.open lot are on site.

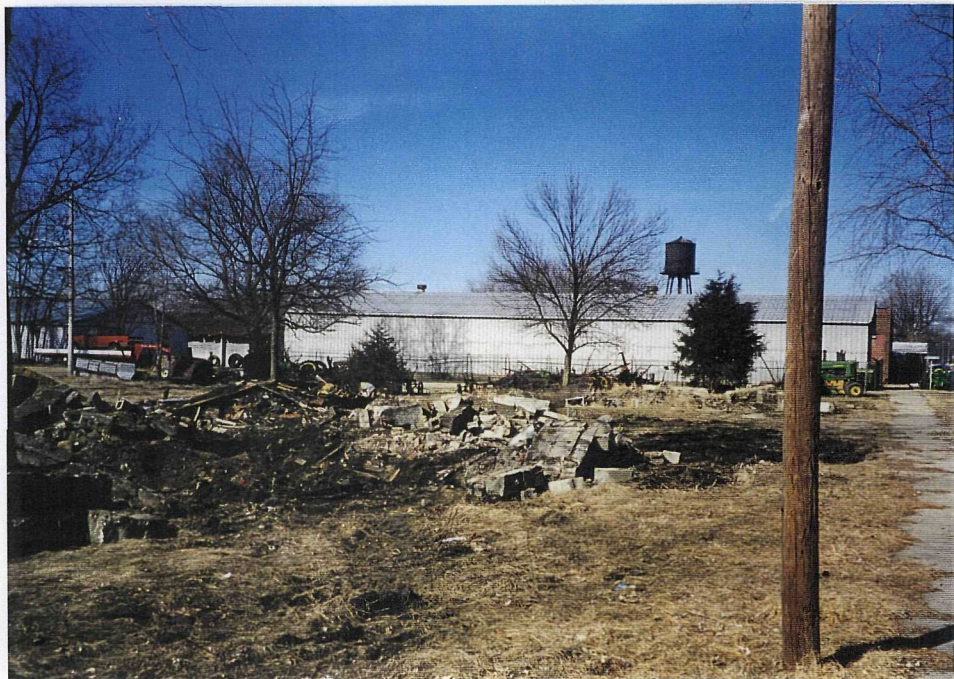
PICTURE TAKEN TOWARD  
the north.

.Photo of empty lot &  
.metal buildings of site.

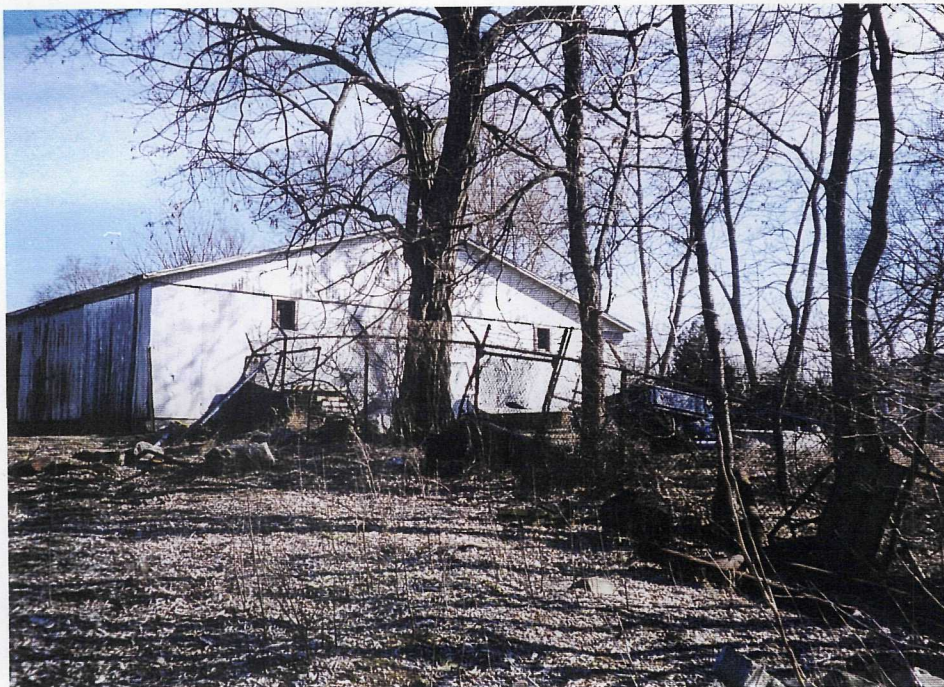
PICTURE TAKEN TOWARD  
the east-southeast  
.Photo of the southwest  
.corner of the site. This  
.is portion of Panorama  
.of photos (3 - 8).

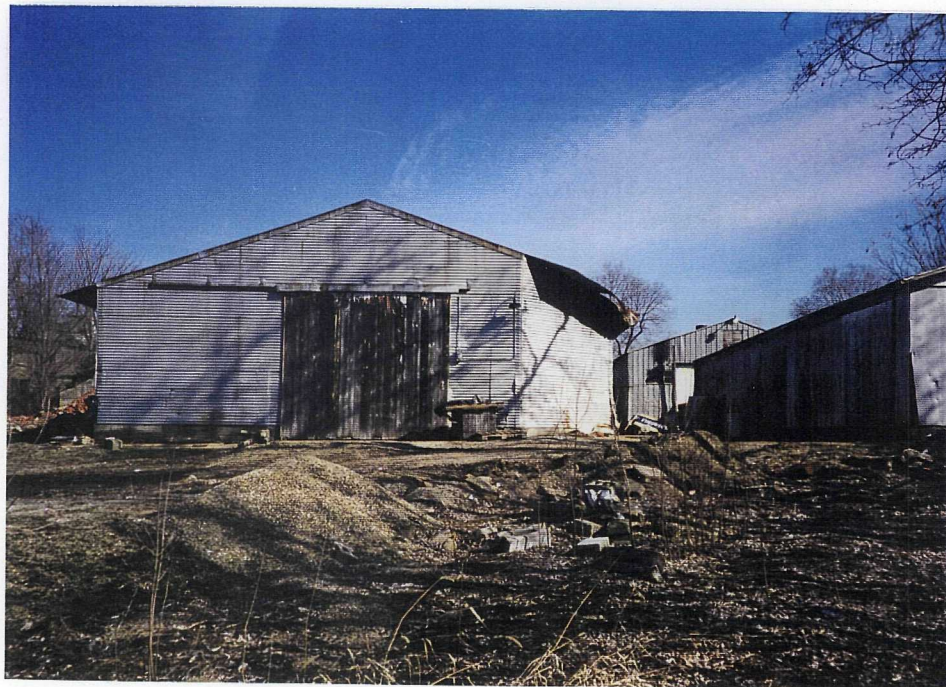
PICTURE TAKEN TOWARD  
the east.  
.Second photo in panorama  
.shows metal buildings &  
.some debris piles.

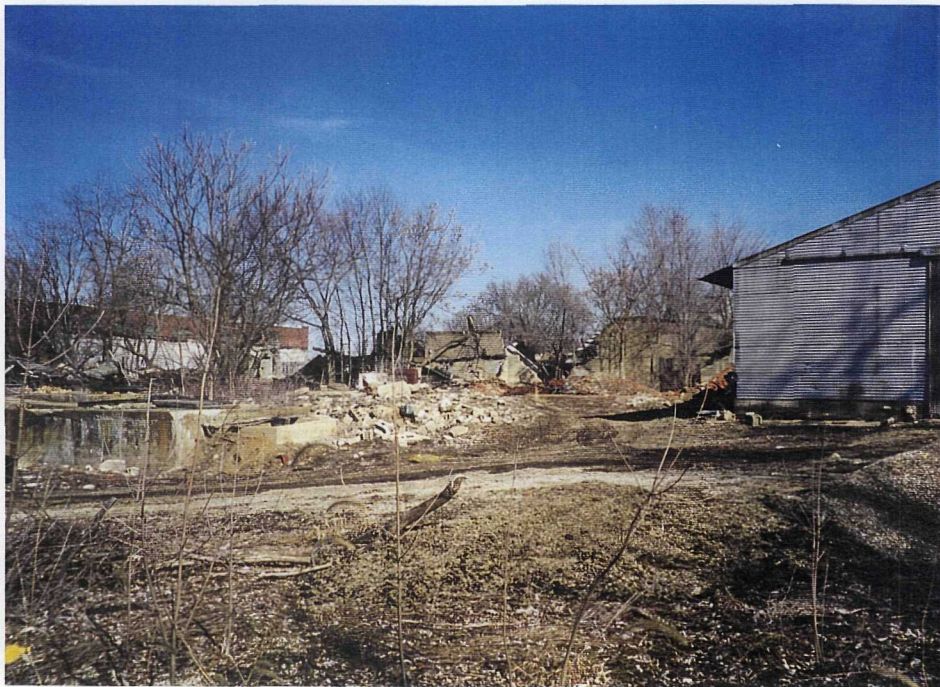
PICTURE TAKEN TOWARD  
the East northeast  
.Third in panorama.  
.Shows portion of collapsed  
.main building & debris .  
.piles scattered over site  
.

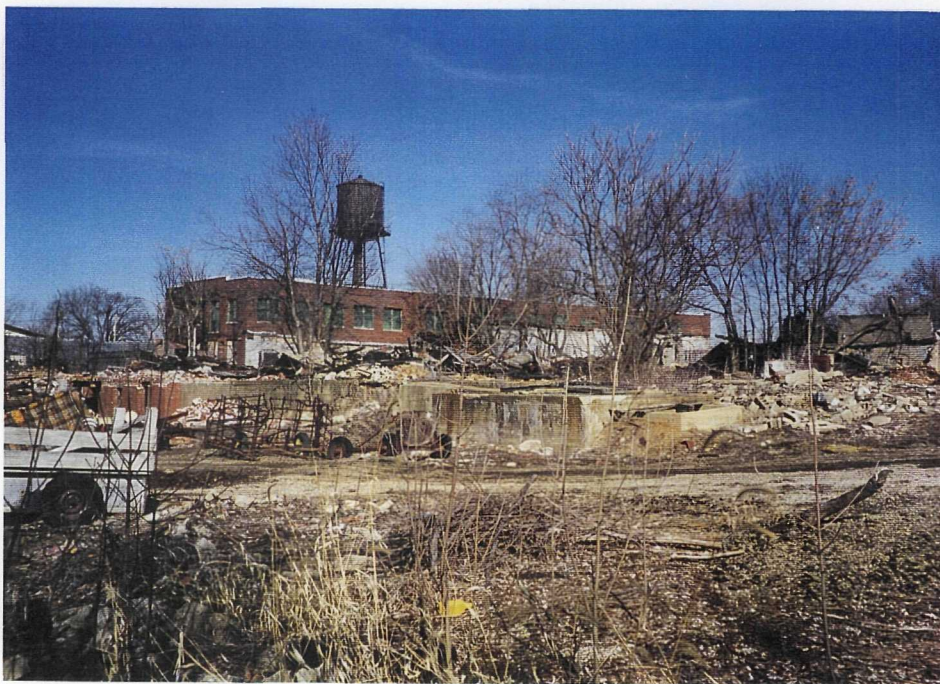
PICTURE TAKEN TOWARD  
the east.  
. Fourth in Panorama  
. Shows debris scattered.  
.through out site. Bldg  
.still standing & water  
.tower are NE edge of .  
.property.

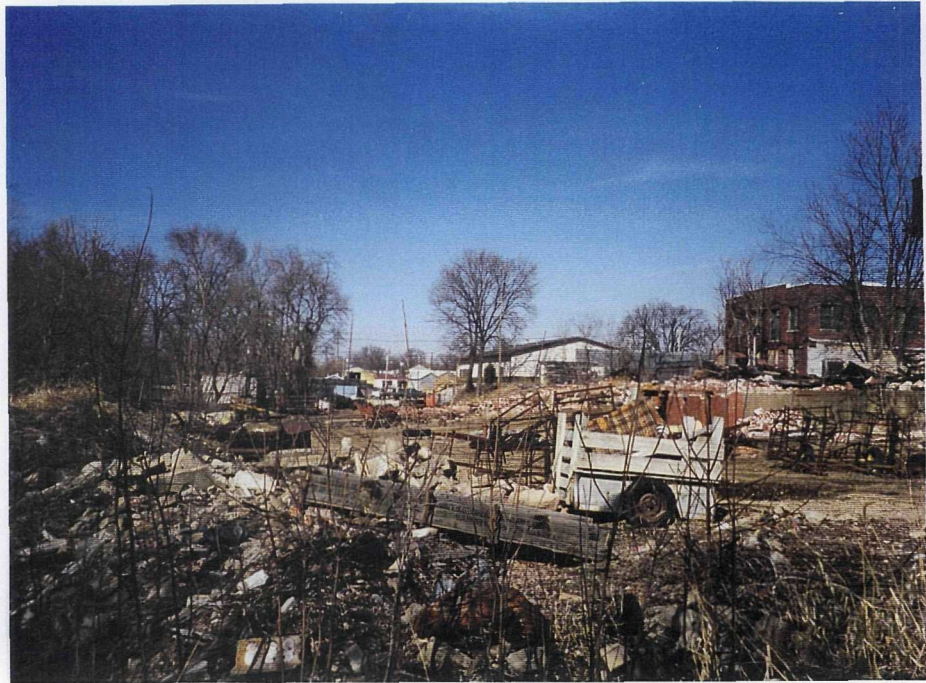
PICTURE TAKEN TOWARD  
the northeast  
.Fifth in Panorama  
. Shows lower portion of.  
.site. Berm in lower left  
.is debris pile & is start  
.of bluff to Illinois River
